## Terex MVP450 Cone Crusher

After Change to our TIC insert cone liner and bowl liners

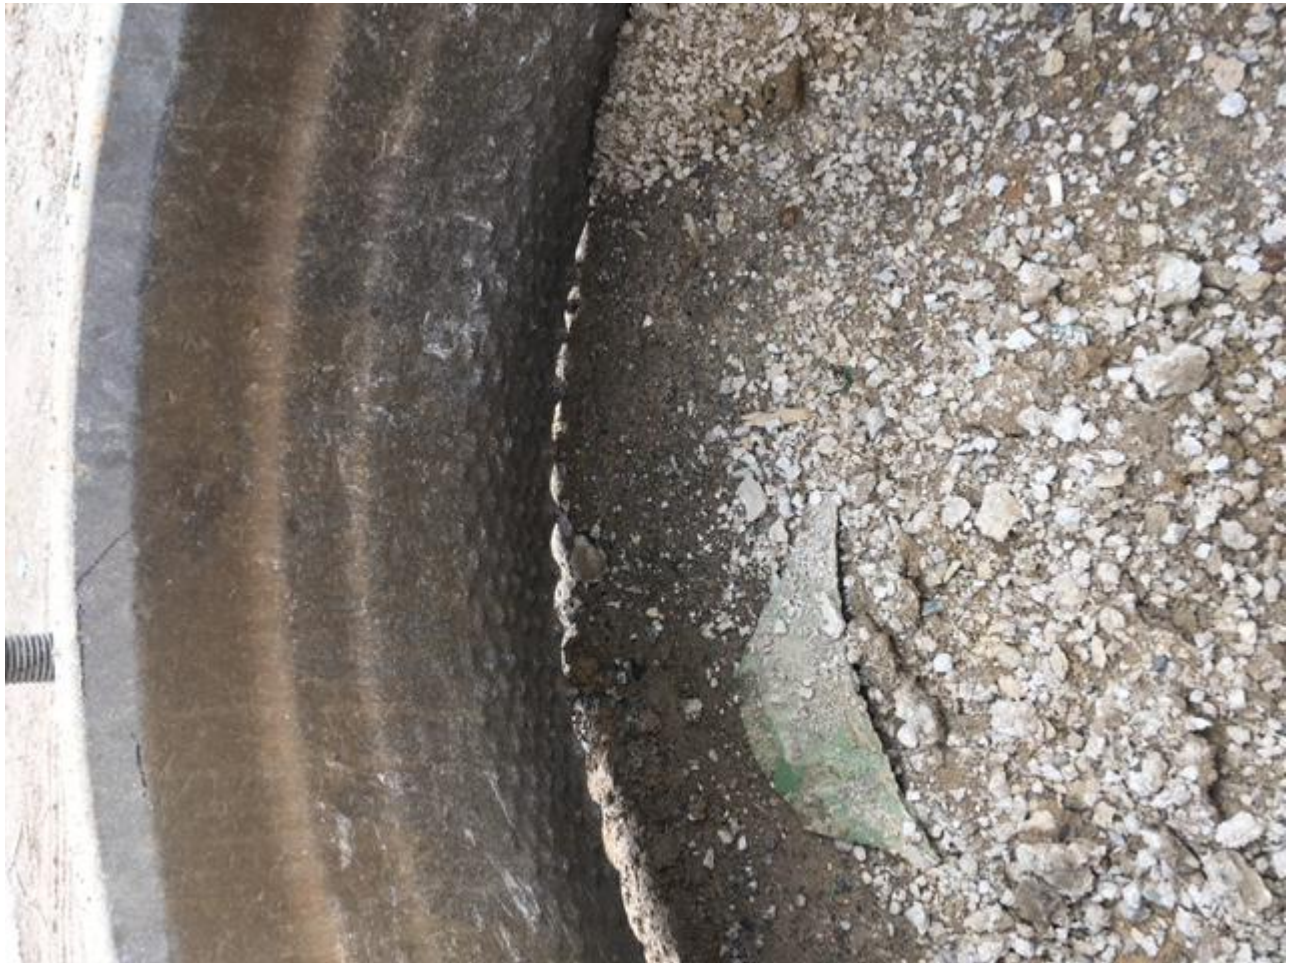
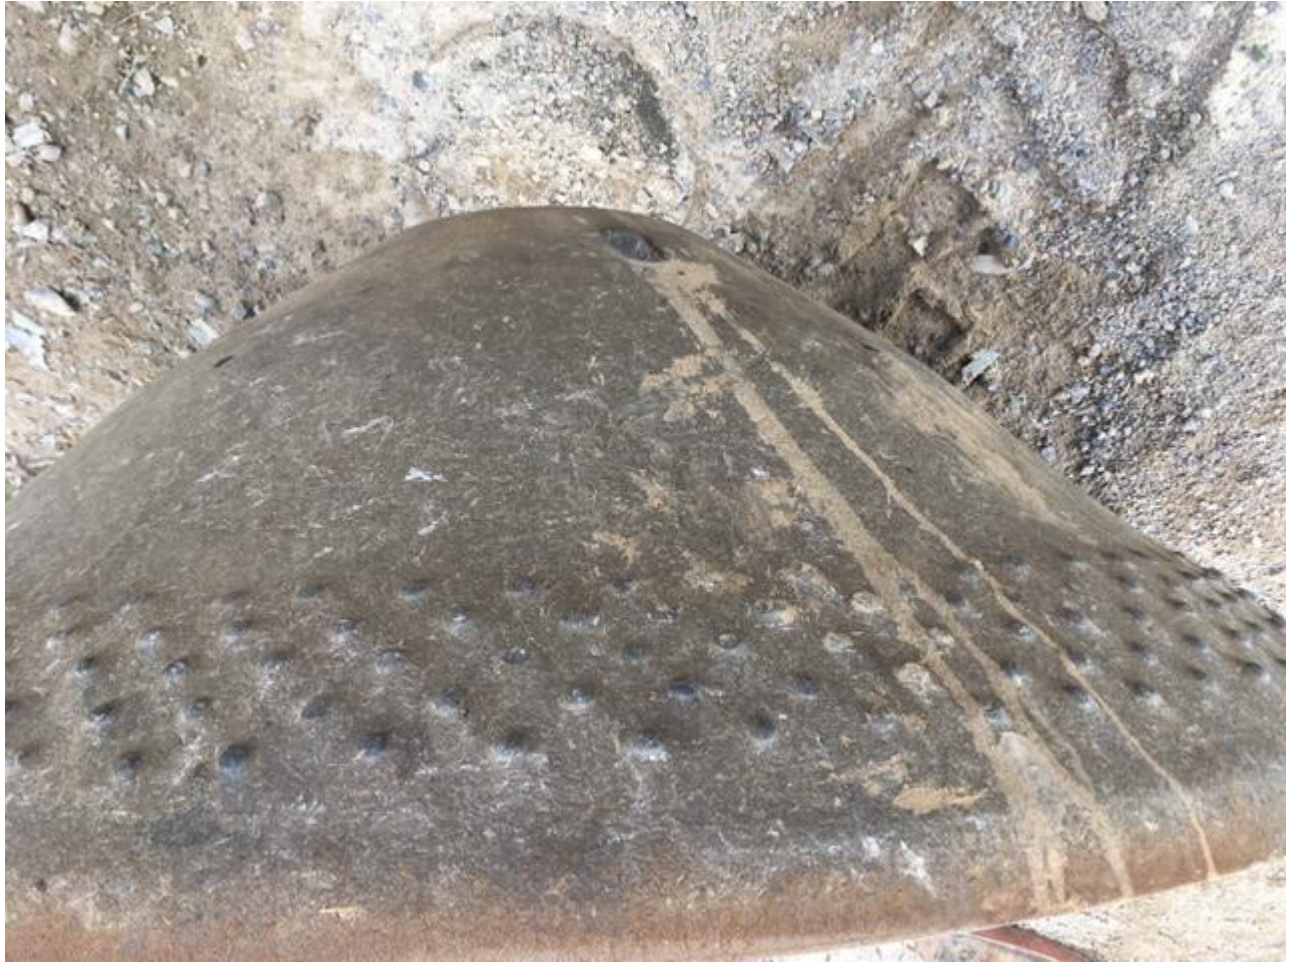
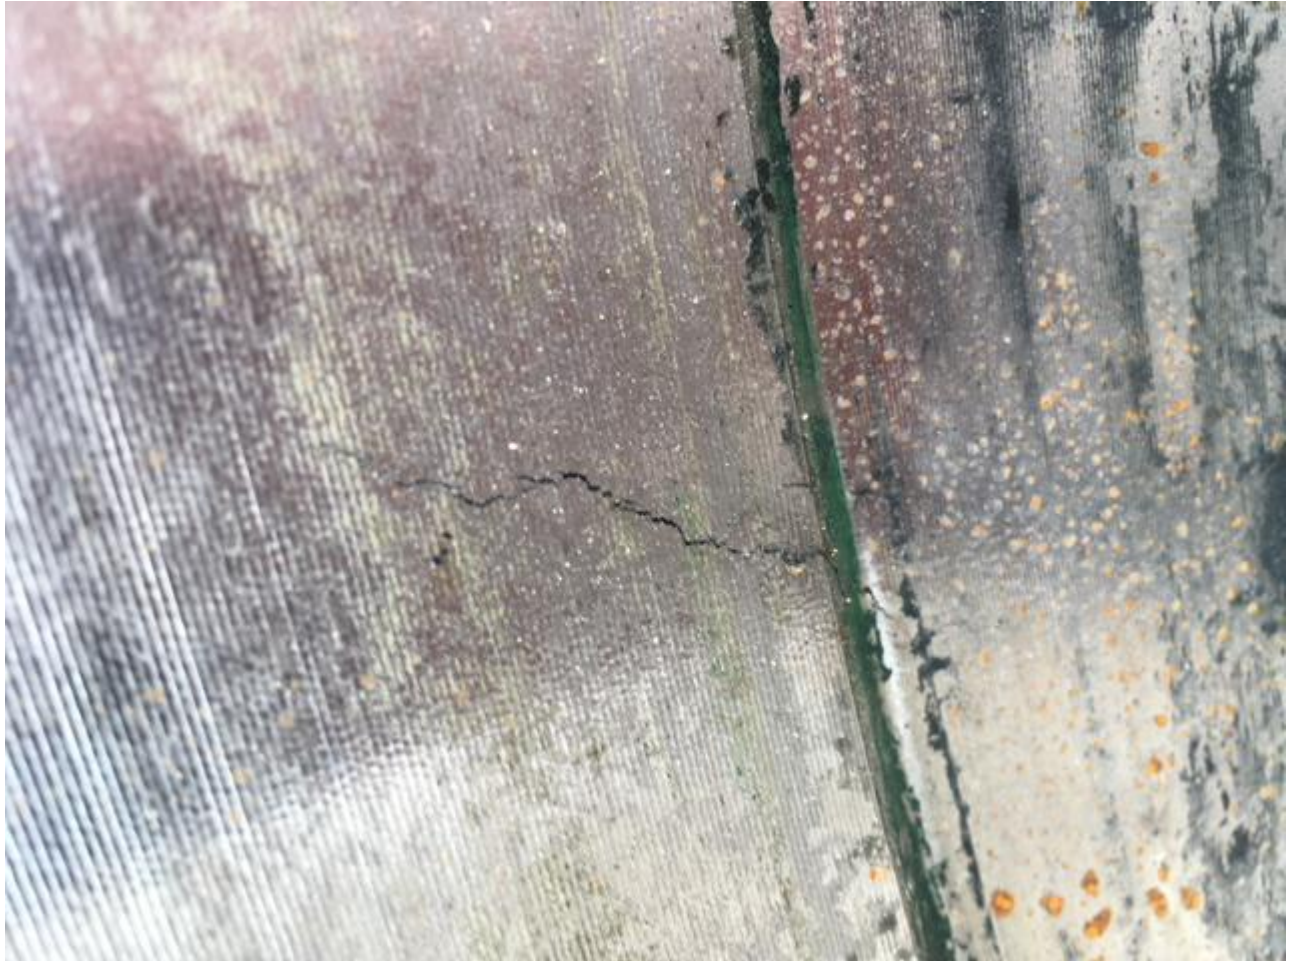
The Wear out Tic insert parts pictures:

After **22 days** working, Our TIC Insert wear parts had taken out, nothing major wrong, **The client we think pulled them out early to be sure they avoid failure. For sure they could've lasted**

longer!!

1. Compare with normal original Mn steel parts, Our TIC insert parts working life more than 2.28 times. Our customer taken out of our parts just avoid failure, our parts can still working after 22 days.
2. No any TIC bars dropped out
3. The TIC insert price just 1.5 times than normal Mn
